Micro SD Card not detected

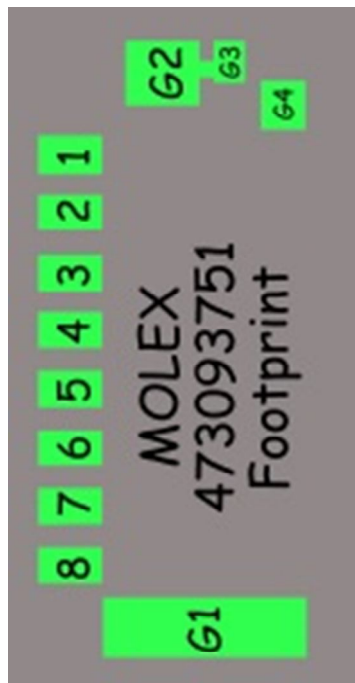
Which Pad (G3 or G4) needs resoldering? This can be checked by probing the switch arms (see photo below), The Top Arm is for G3 (should be Gnd) and the Bottom one is for G4 (should go to D5 & D6 – See Picture `A'), resolder the one that doesn't get continuity.

Another problem I came across recently is the connector itself had a `dicky' switch (see the photo below of a good switch), I chased my tail trying to solder and resolder Pads G3 and G4 only to find that the switch was malfunctioning, if this is the case just bent the two arms on the contact to make sure they meet properly when a uSD card is inserted.

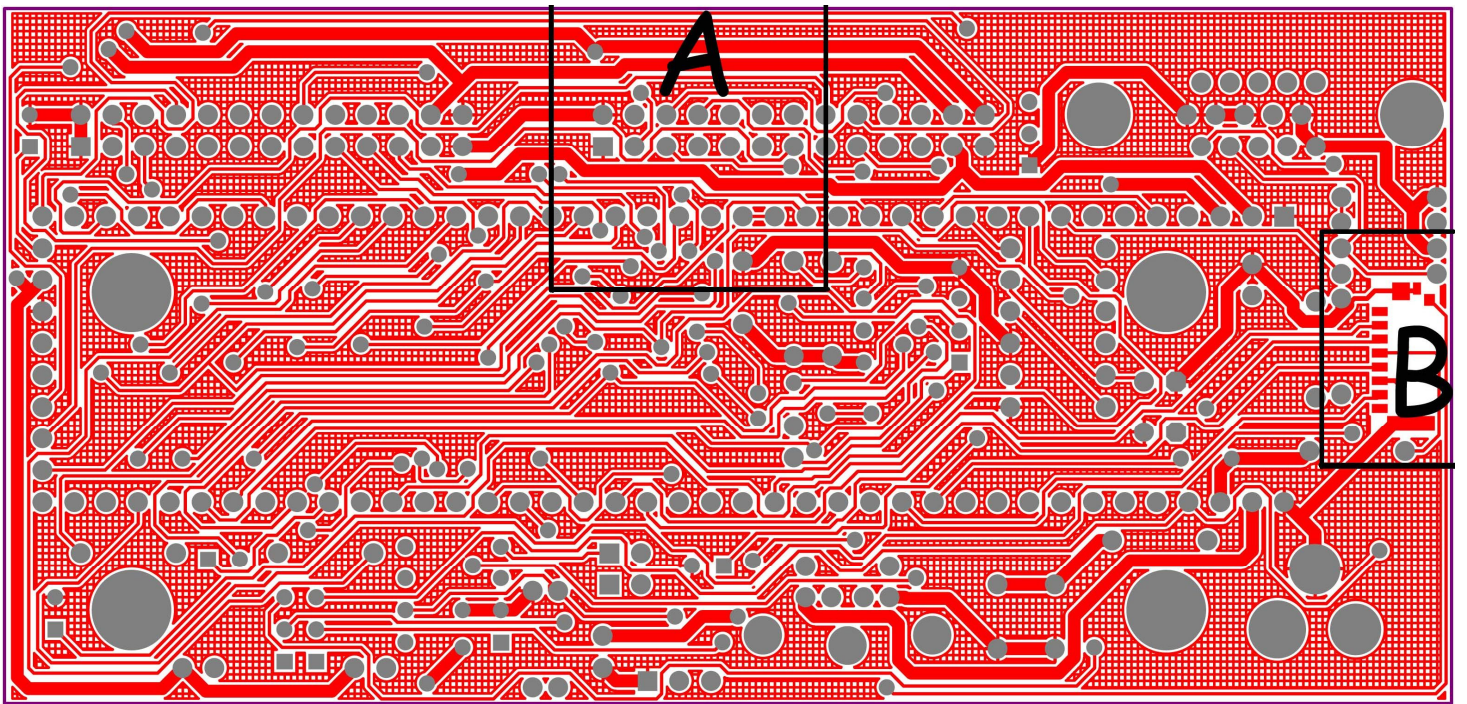
A work around, providing you do not need the Detect of the uSD card present is to permanently wire D5 and D6 to Gnd, Nearby Gnd locations can be seen in Picture `A'. This will not cause any problems except if you try to access the uSD card and it is not present (an error will occur).

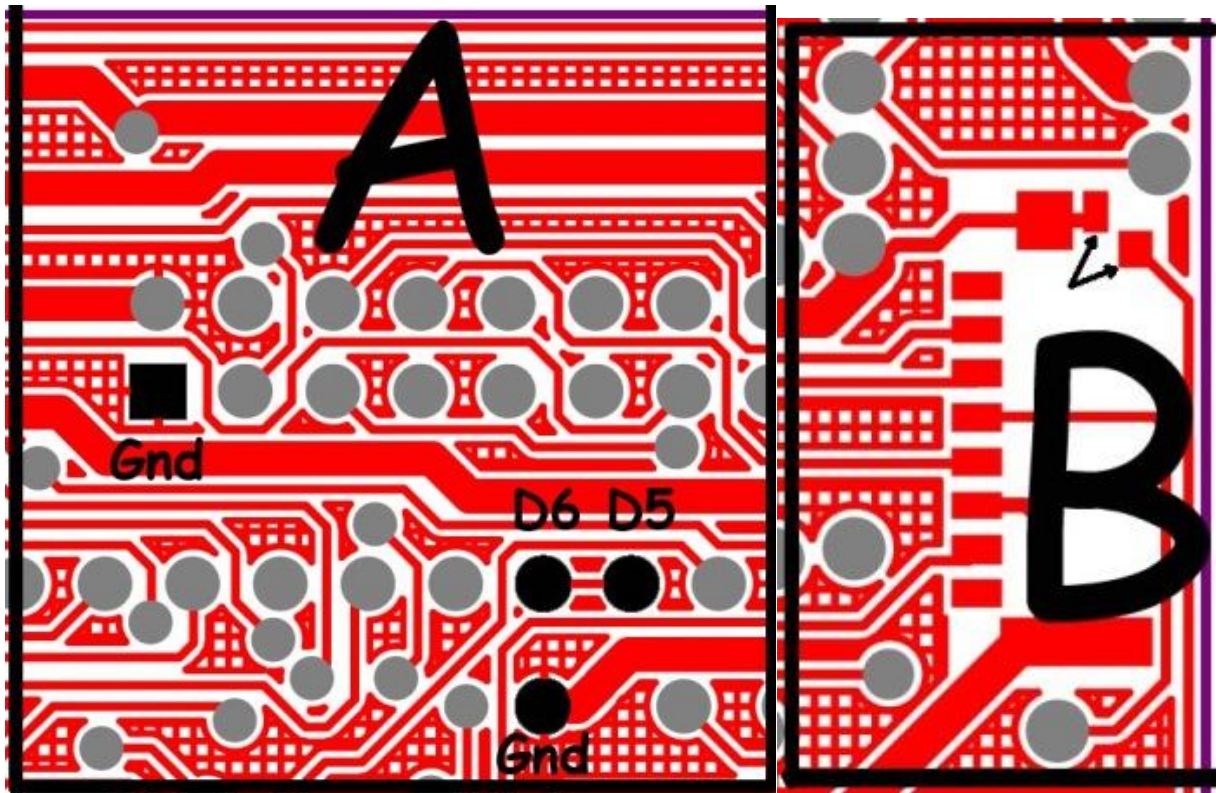
The Pads G3 and G4 of the uSD connector are pretty hard to solder. I made the footprint of the PCB exactly as per the manufacturers spec but as this is generally a production wave soldered part I really should have made these pads longer so they protrude beyond the body of the connector so soldering would be easier.. Another lesson learned.

The points in question are shown arrowed in Picture `B'. To resolder these will need a couple of parts, R4 and possibly D5) removed to try to access them to resolder. This is difficult unless you have a very sharp iron and a magnifying lens.
